SITE 023 TRACK 1 DECISION DOCUMENTATION PACKAGE, OU 10-08

DECISION DOCUMENTATION PACKAGE COVER SHEET

Debris in Birch Creek Drainage Gravel Pit

023

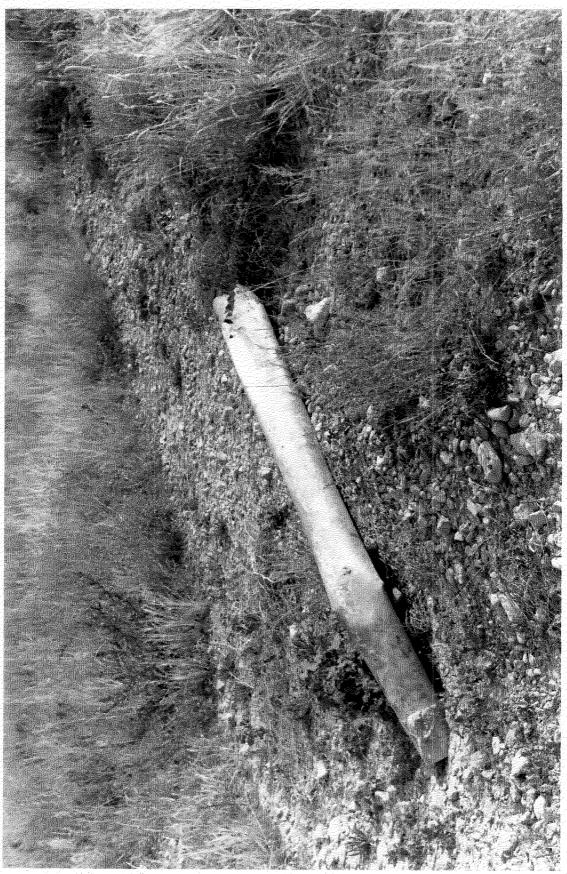
Site: 023 Debris in Birch Creek Drainage Gravel Pit (PN99-0456-1-1)

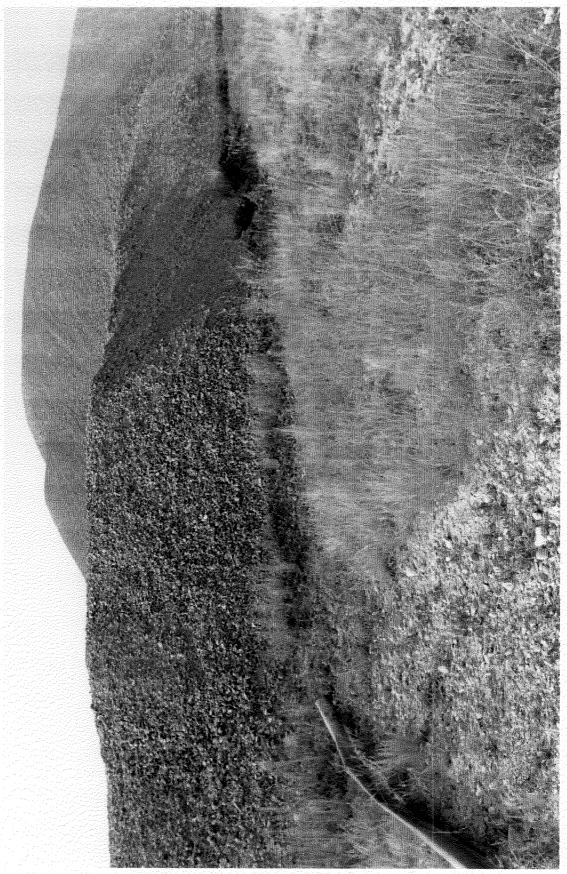
Site: 023 Debris in Birch Creek Drainage Gravel Pit (PN99-0456-1-3)
